# Climate Change & Extreme Weather Pilot Project

**OFFICE OF STRATEGIC PLANNING AND PROJECTS  
CONNECTICUT DEPARTMENT OF TRANSPORTATION**

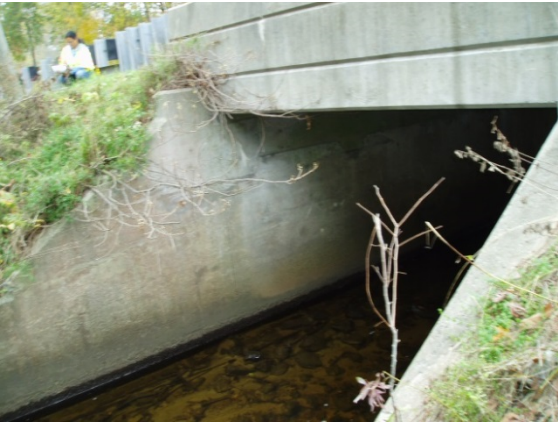
# STRUCTURE NO. 02315 HEADWATER DEPTH VS. PEAK DISCHARGE

Example: Little to No Adaptive Capacity

# Low Adaptive Capacity Structure Barkhamsted- Route 44

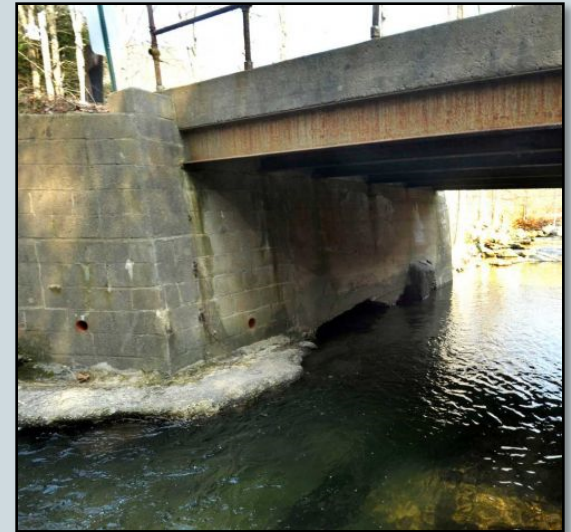
Example of bridge scour,  
New Milford

- Scour
  - Mapped scour critical structures
  - Velocity during storm events contributes to scour
- Susceptibility to debris accumulation
- Excessive backwater, i.e. upstream pooling
- Precipitation projections
  - Precip.net vs. TP-40
  - Broad percentages vs. incremental increases
    - ✦ Incremental increases better gauge adaptive capacity
