**On the Front
Line:
Living Shorelines – A
Municipal Perspective**

Denise Savageau
Conservation Director
Town of Greenwich

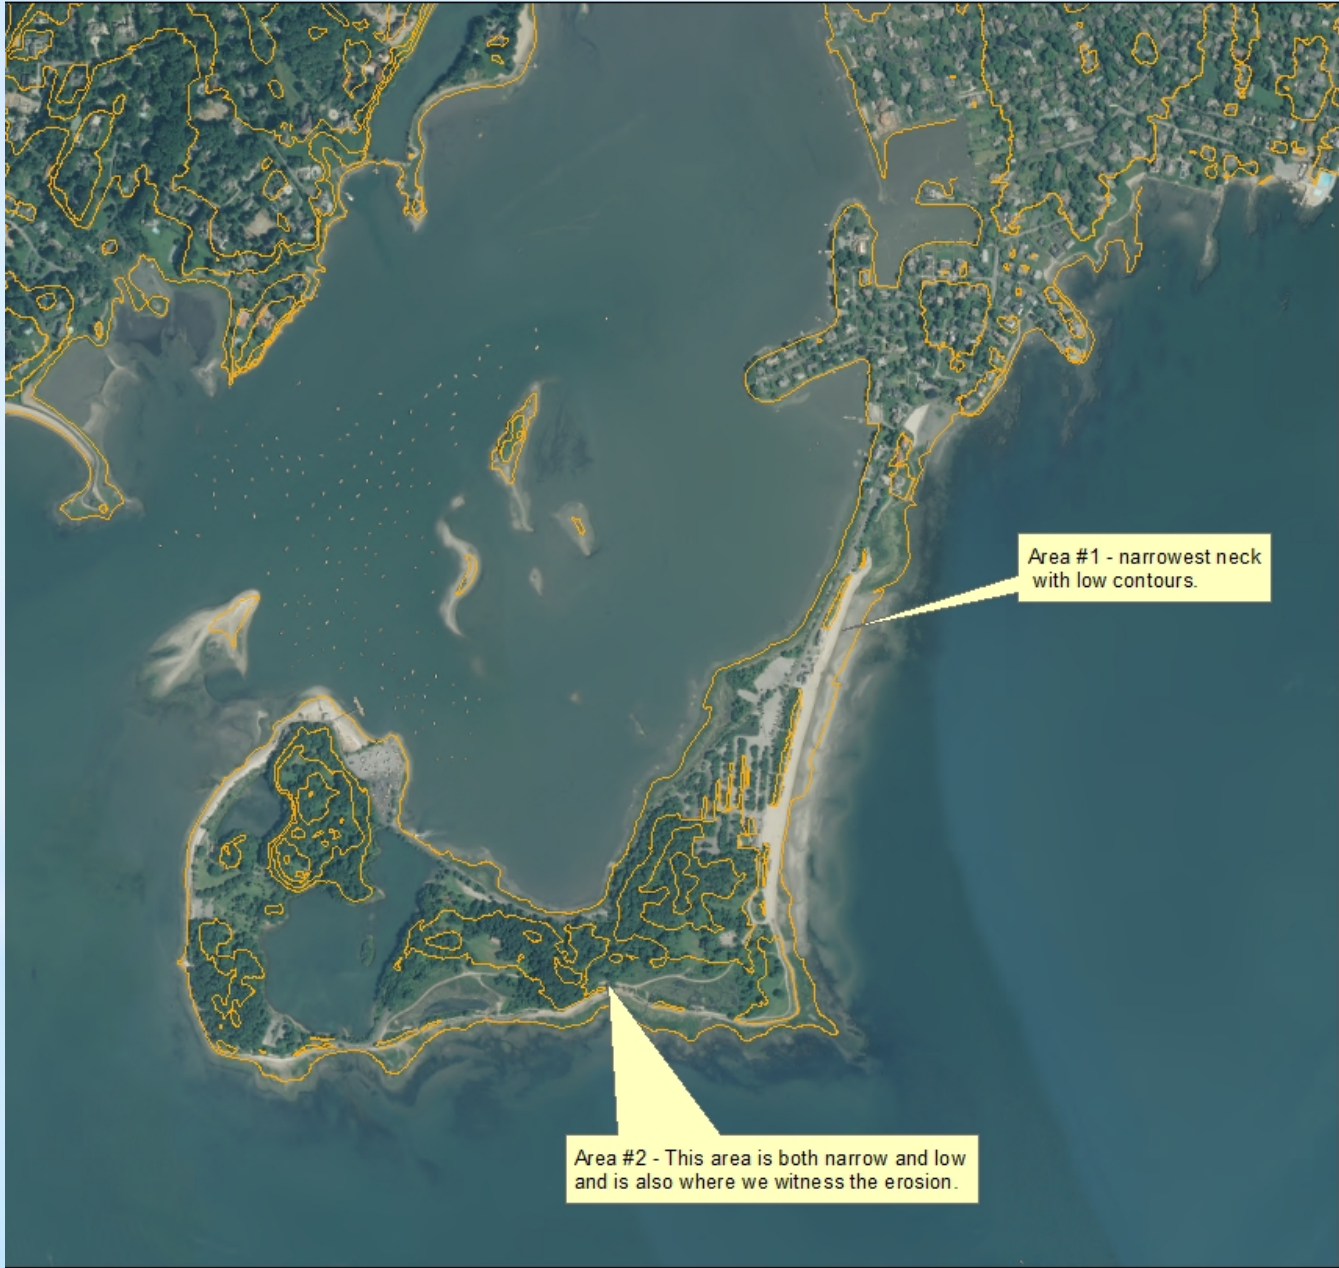
Area #1 - narrowest neck with low contours.

Area #2 - This area is both narrow and low and is also where we witness the erosion.
