Jordan Cove

URBAN WATERSHED PROJECT

University of
Connecticut
College of Agriculture
and Natural Resources

ABOUT THE PROJECT

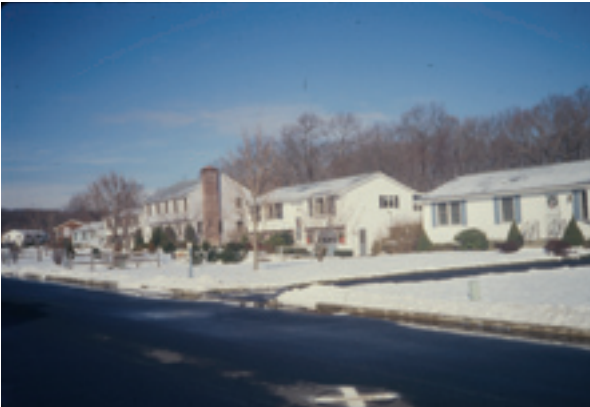
CONTROL WATERSHED

The control watershed was an existing 14 acre residential watershed containing 43 lots built in the same general vicinity of the treatment watersheds in 1988. Stormwater runoff was monitored at the outflow of a stormwater pipe at the watershed outlet.

This watershed allowed us to adjust for weather differences year-to-year.

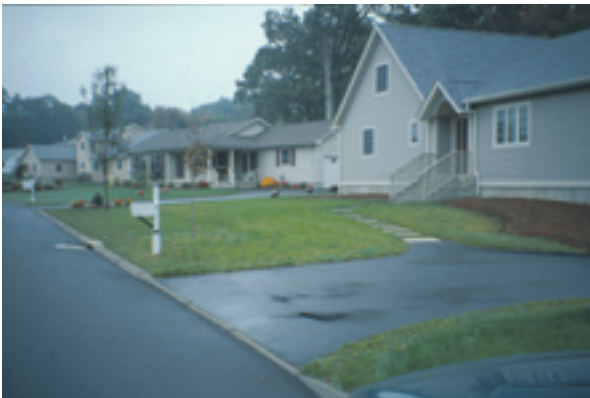
TRADITIONAL WATERSHED (TREATMENT)

The traditional watershed was five acres in size and now contains 17 residential lots. This watershed was developed using standard zoning and construction practices. It is accessed by a 24 foot wide asphalt road with typical curb and gutter stormwater conveyence system.

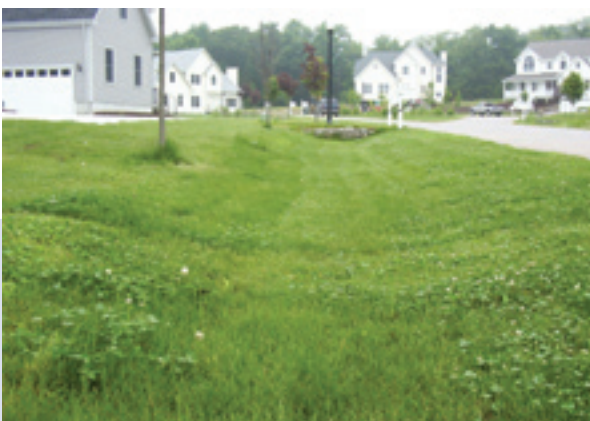
BMP WATERSHED (TREATMENT)

The four acre BMP watershed now contains 12 lots. A cluster approach was used to aggregate homes closer together, leaving more open space in the watershed. Shared driveway entrances reduce imperviousness. Lawn sizes are reduced and low-mow and no-mow areas are designated to reduce fertilizer and maintenance impacts. The access road is narrower (20 ft.) than typically allowed by ordinance and is constructed of interlocking concrete pavers that allow infiltration.

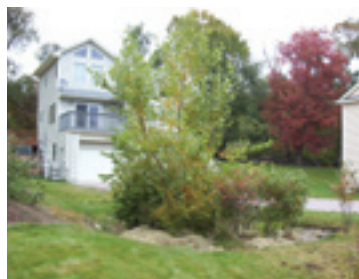
Rain Gardens

Each lot contains a rain garden. These shallow depressions are designed to temporarily collect and treat runoff from roofs and yards.

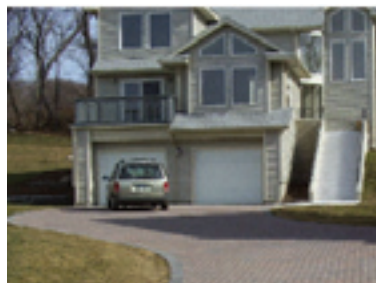
Driveways are constructed of different materials (crushed stone, pavers, asphalt) to compare runoff and pollution from them. Most driveways have shared entrances to reduce impervious surfaces.

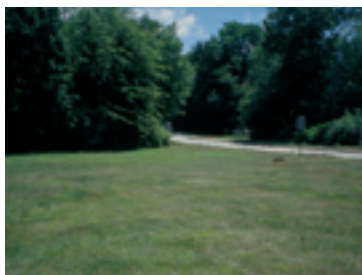
Open space

A large portion of the subdivision is dedicated to open space and common usage.

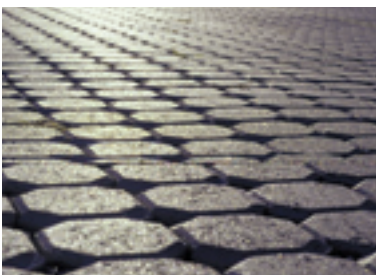
Road

The main road is constructed with concrete pavers. These pavers allow infiltration of water through their open corners, and reduce stormwater runoff.

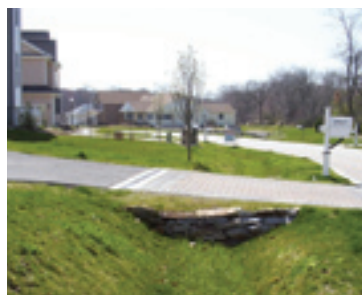
Swales

Located along the sides of the roadway, these grass-lined channels are intended to slow runoff and allow water to infiltrate into the ground before leaving the subdivision. They replace a curb-and-gutter stormwater collection system.

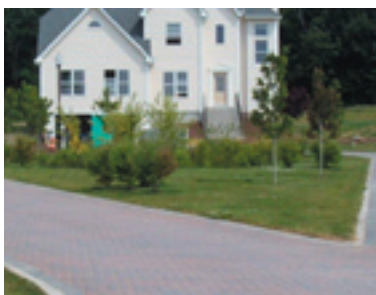
Cul-de-sac

Another rain garden (bioretention area) is located in the middle of the cul-de-sac. It is designed to collect and filter runoff from the road.

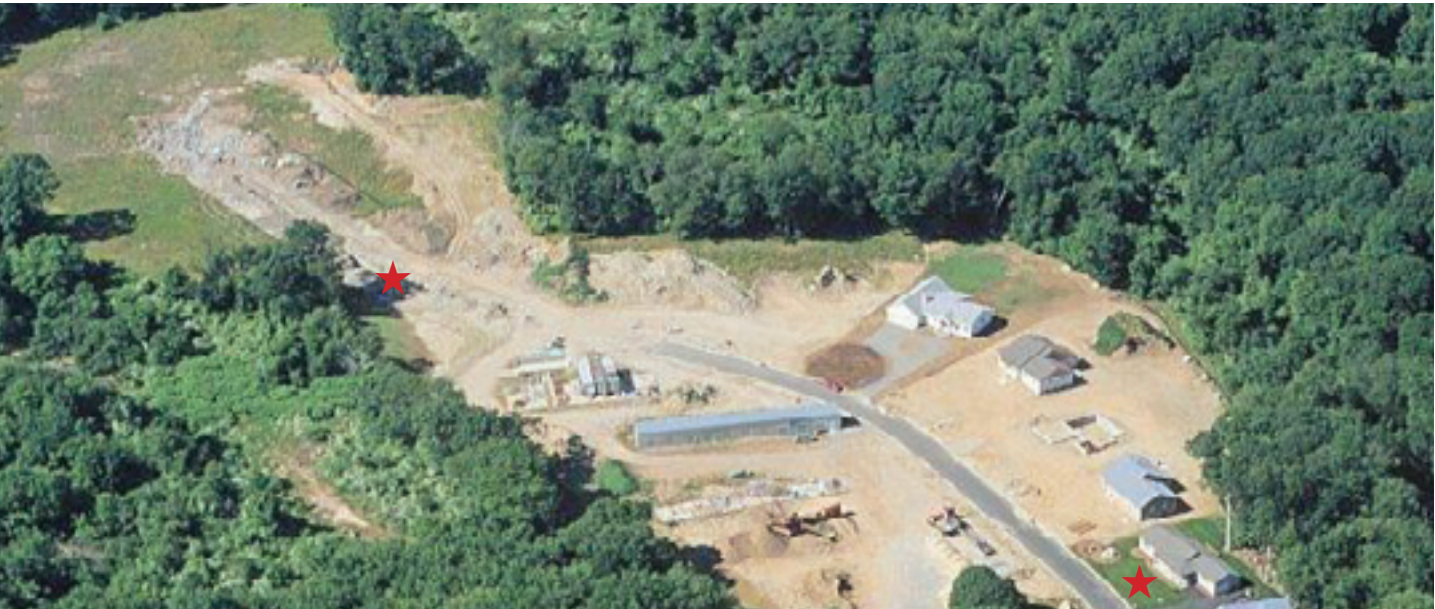
★ Monitoring Locations

BMPs WORK! BMP STORMWATER RUNOFF WAS MUCH LOWER THAN FROM THE TRADITIONAL WATERSHED DURING CONSTRUCTION.

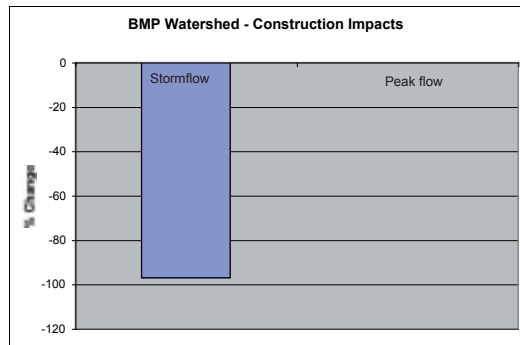
- Runoff volume did not increase from the BMP Watershed because of a berm, swales, pavers, temporary retention basins.

% change from level expected by calibration.

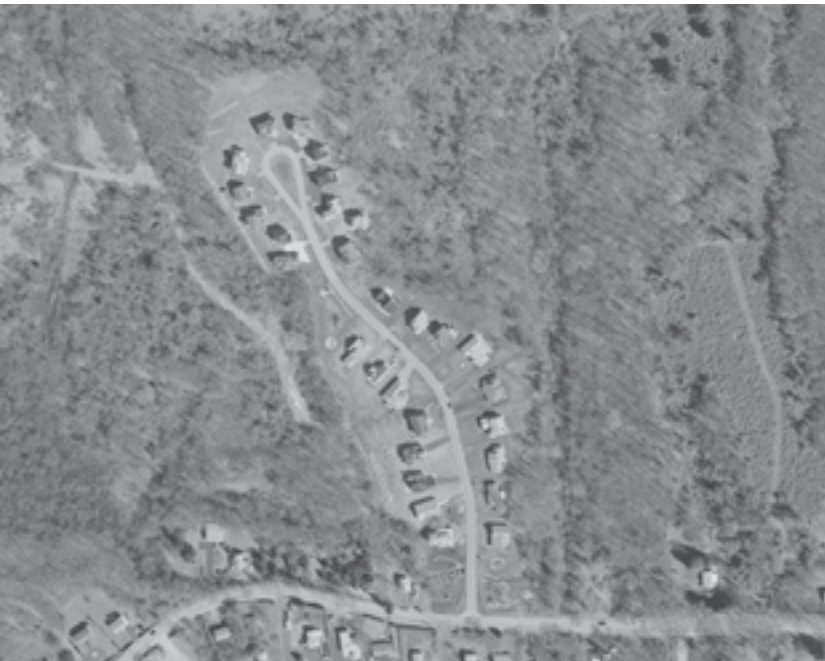
Stormwater runoff during this storm in 2003 showed a much lower peak and volume of runoff from the BMP watershed than from the others. The peak was delayed 15 minutes after the peak from the traditional watershed.

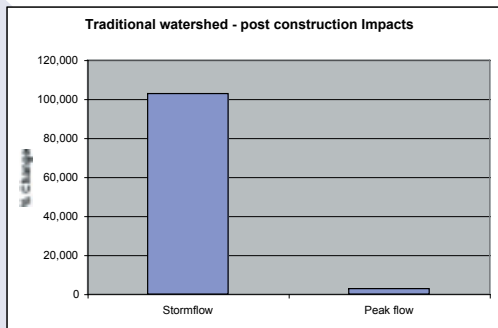
- Runoff volume and peak increased from the Traditional Watershed because of the impervious road surface.
