# Site A-5: Warehouse and Motor Pool

Perimeter Sand Filter/ Green Roof at Stormwater Hotspots

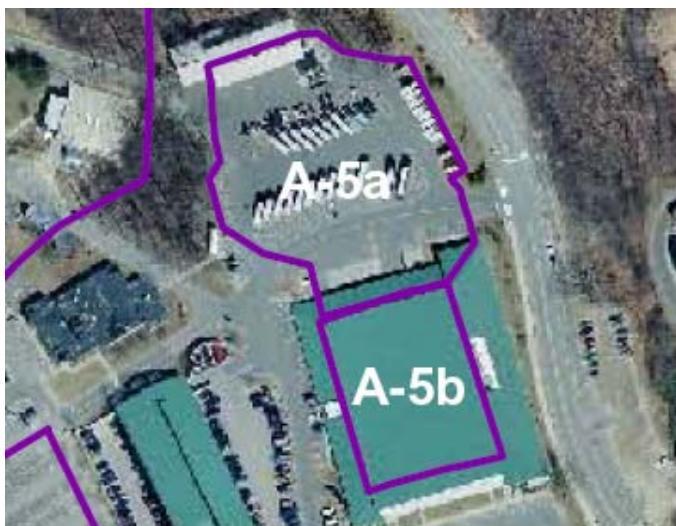
filter (A5-a) and green roof (A-5b).

The proposed retrofit concept is located on the UConn Campus at the motor pool and warehouse east of the facilities building (Figure 1). The motor pool's parking area is entirely impervious, with some indications of oil spillage near the fueling area. The warehouse has a large, flat roof.

Install a perimeter sand filter to capture motorpool parking lot runoff (Site A5a), and a green roof on the rooftop (Site A5b). Convey overflow from these practices to the existing storm drain system.

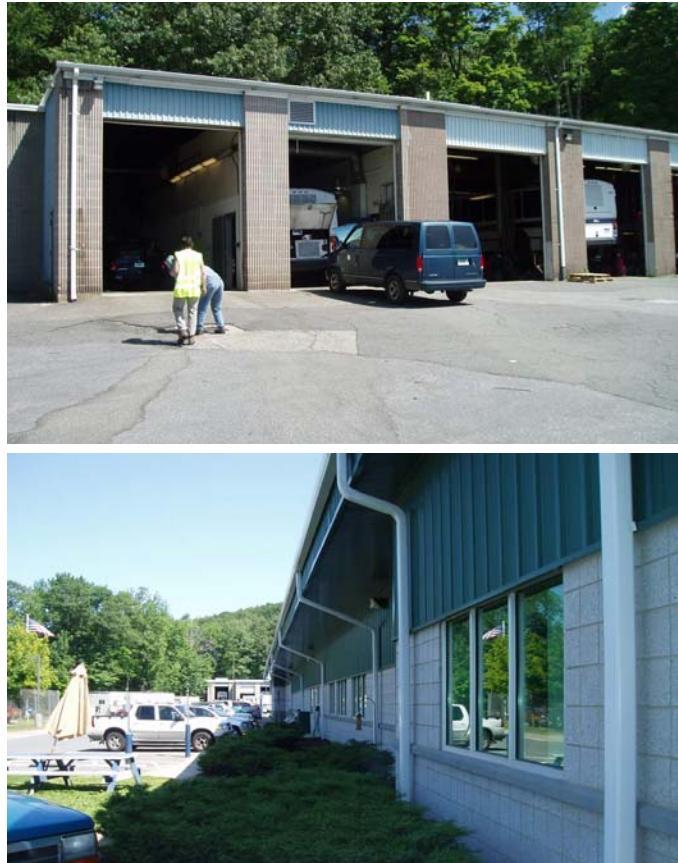
rooftop drains from warehouse to storm drain (lower).

Runoff from this site is captured in an enclosed storm drain system. Although there appears to be a trap to capture drainage from inside the building, presumably leading to the sanitary sewer system, there is currently no stormwater treatment on the site. Consequently, the potential for automotive contaminants (i.e., oil, antifreeze, brake fluid) to come into contact with stormwater is high (Figure 2).
